National Transportation Safety Board

RRD22LR008 - BOSTON, MASSACHUSETTS

MECHANICAL

Factual Report

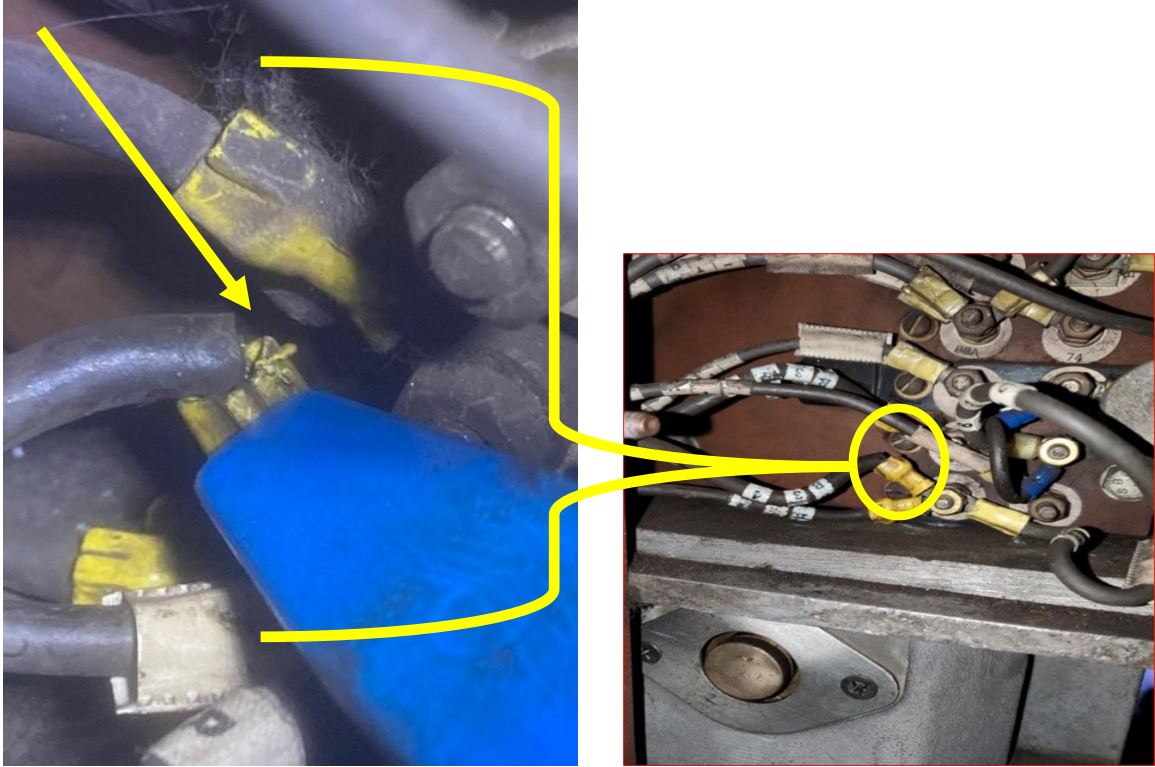
Figure 3. Photos of Electrical Bypass on Propulsion Circuit

26 Testing of the train consist determined the fault that allowed the train to move
27 with the doors in an open position was located on lead car 1511. Examination of the
28 train door and trainline propulsion circuits found that trainline propulsion was
29 energized with 37 volts and was not affected by any changes to the state of the door
30 interlock relay. Further examination of the Cineston electro-mechanical contact
31 connections (wire terminal board and finger contacts) located under the master
32 controller of the lead car, found that wires protruding out of the crimped terminal of
33 wire B3 were completing an electrical contact with the mounting screw where the B3A
34 wire was connected.

35 A review of the circuit schematics determined that the unintended electrical
36 connection (short) was bypassing the door interlock relay and therefore provided 37
37 volts to enable trainline propulsion. (See Figure 3)
